Determination of the structural integrity of cable installation chambers by vacuum tests.

| Requested by: Vesimentor OÜ

Task Determination of the structural integrity of cable installation chambers by vacuum tests.

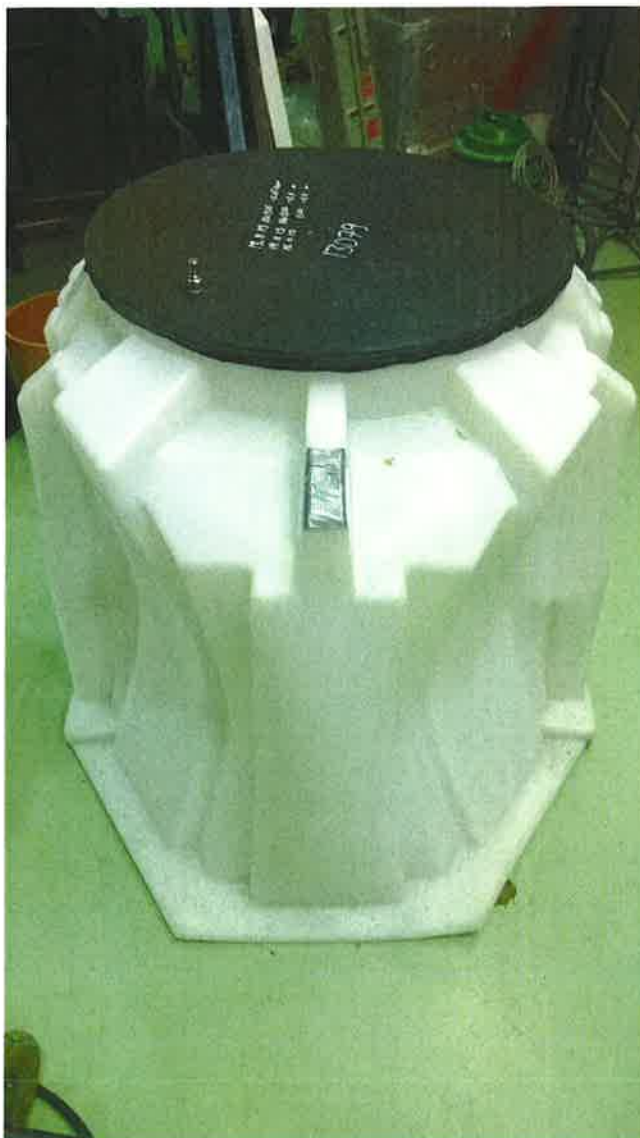
The KKS2 chamber was tight until 0.11 bar vacuum. The long sides buckled in (picture 1) and the handles started leaking.

Picture 1 (KKS2: 0,11 bar vacuum)

The tested KKS3#II chambers can take 0.2 bar vacuum without collaps and are thereby in our opinion suitable as cable chambers in properly constructed traffic areas where the vehicle maximum weight do not exceed 12 tons. The KKS2 chamber should not be placed in traffic areas for heavier than 3,5 ton vehicles.

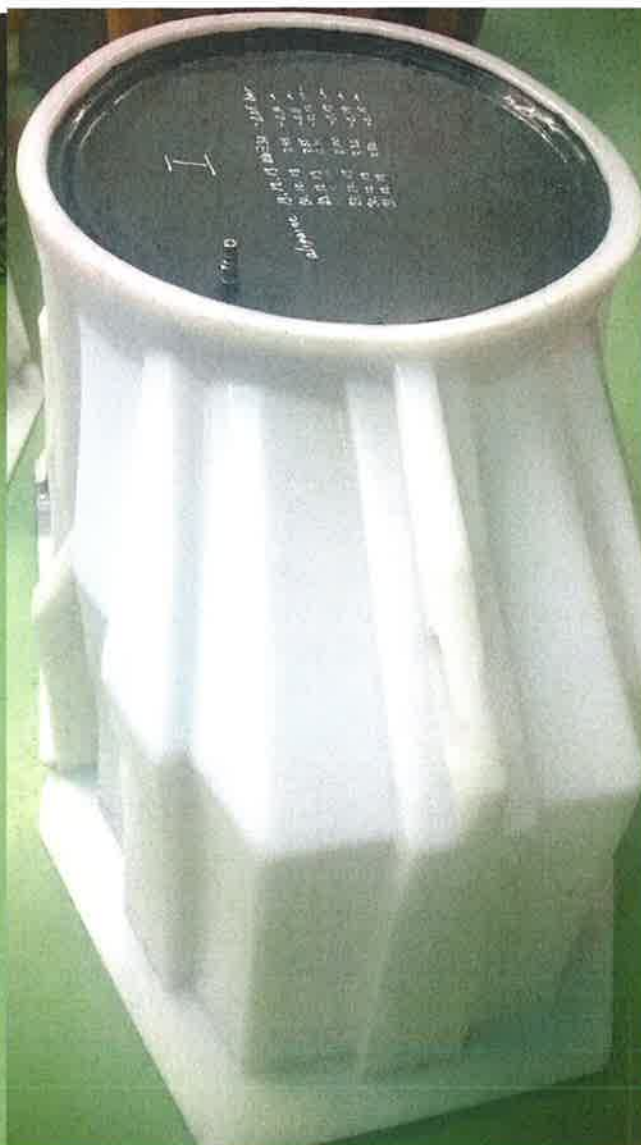
The KKS3 #1 chamber was tight until 0.16 bar vacuum. The long sides buckled in only slightly (picture 2). Both chambers were very stable until 0.15 bar vacuum.

Picture 2 (KKS3 # I : 0,15 bar vacuum)

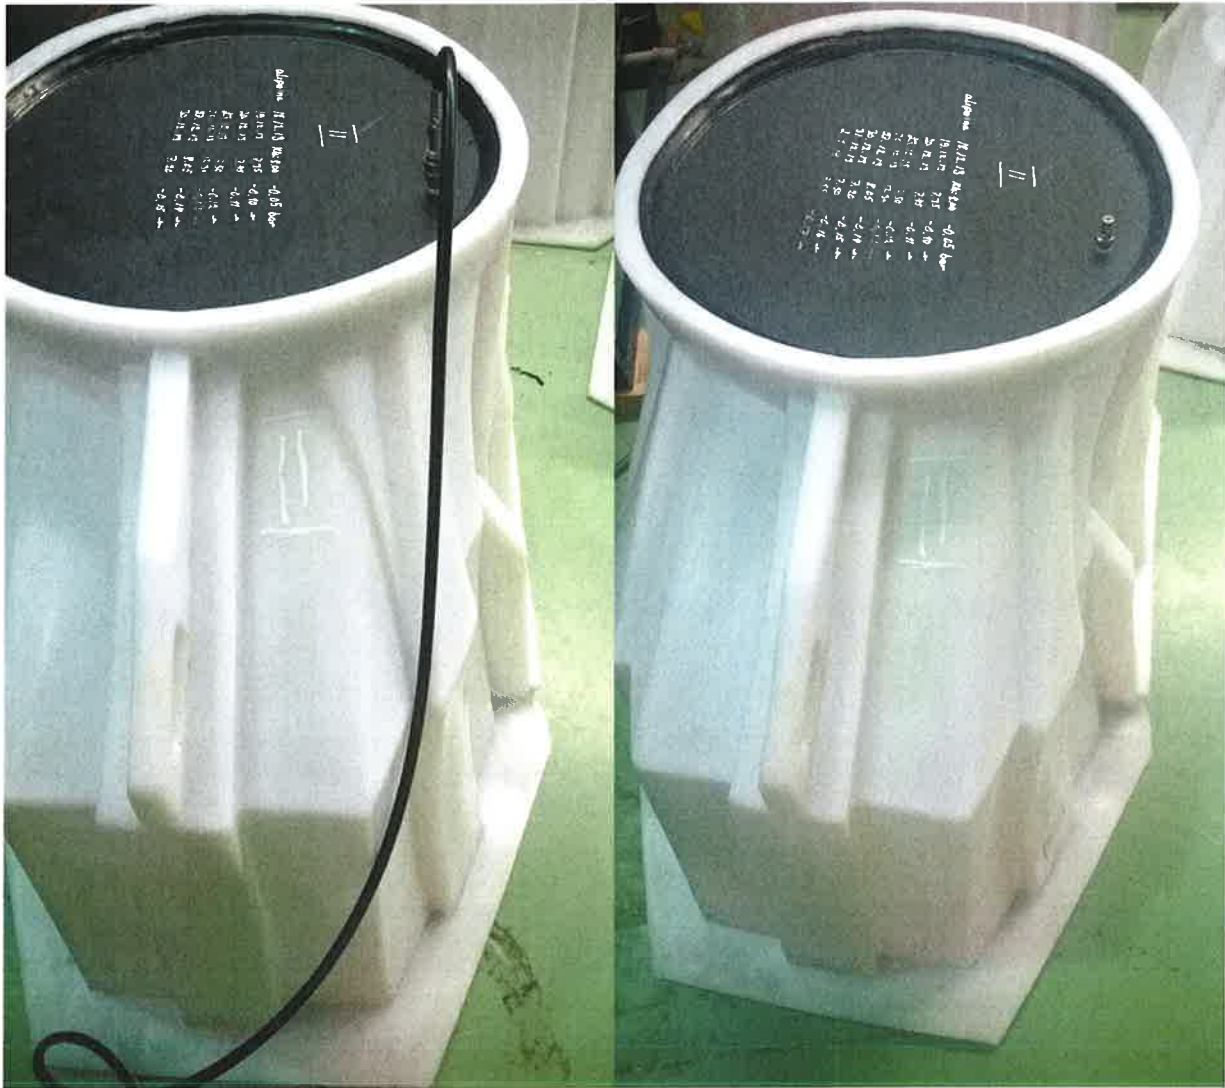
The buckling of KKS3 #2 chamber is shown in pictures 3...11.

Picture 3 (KKS3 # II : 0,15 bar vacuum)

Picture 4 (KKS3 # II : 0,17 bar vacuum)

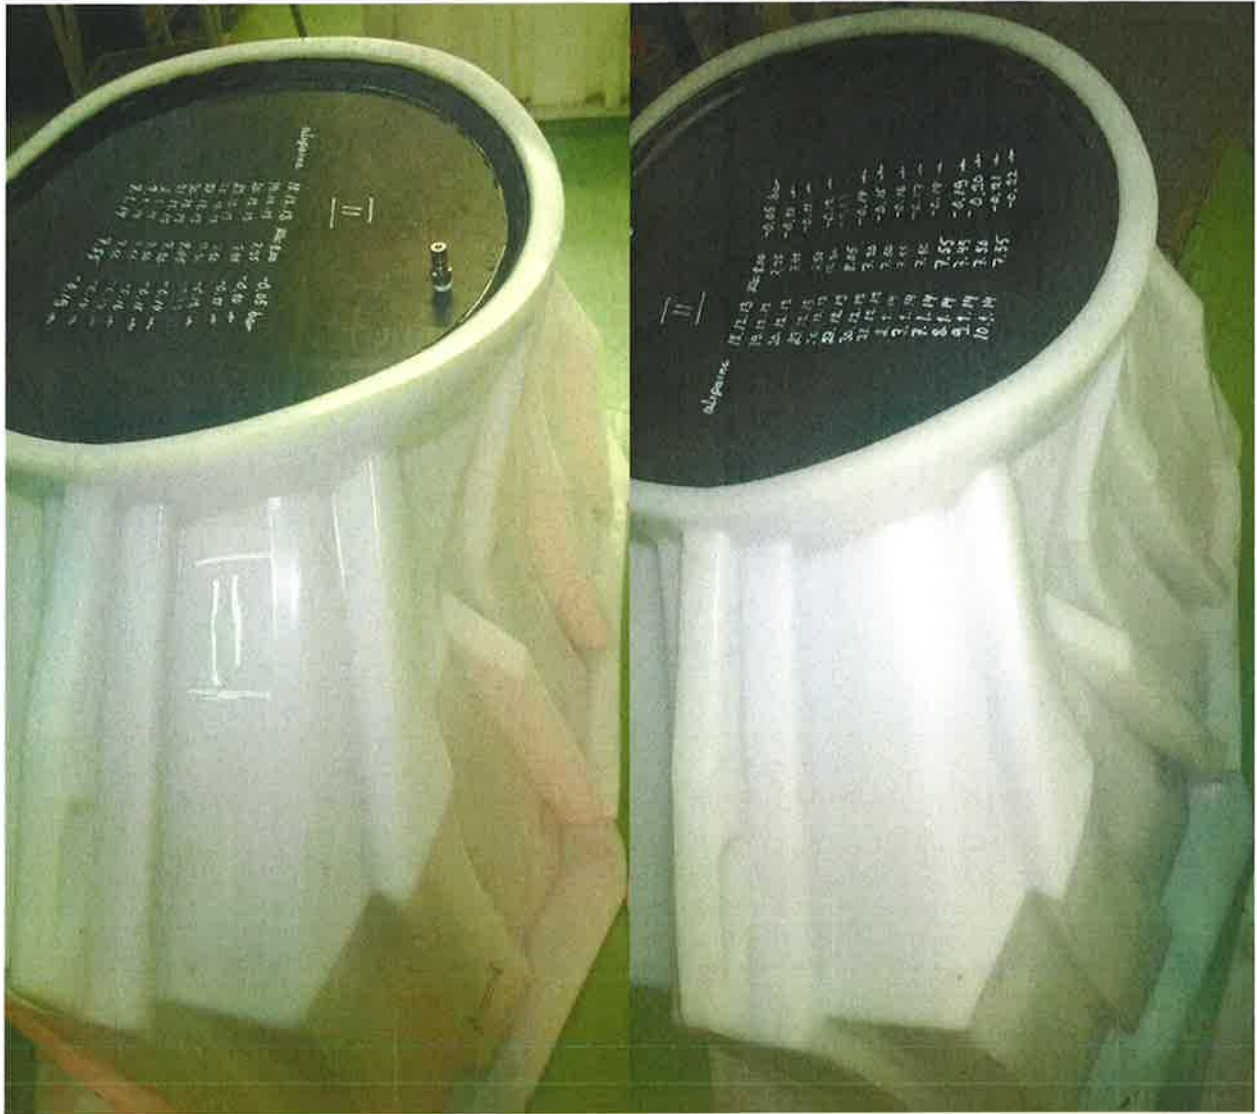
Picture 5 (KKS3 # II : 0,19 bar vacuum)

Picture 6 (KKS3 # II : 0,22 bar vacuum)

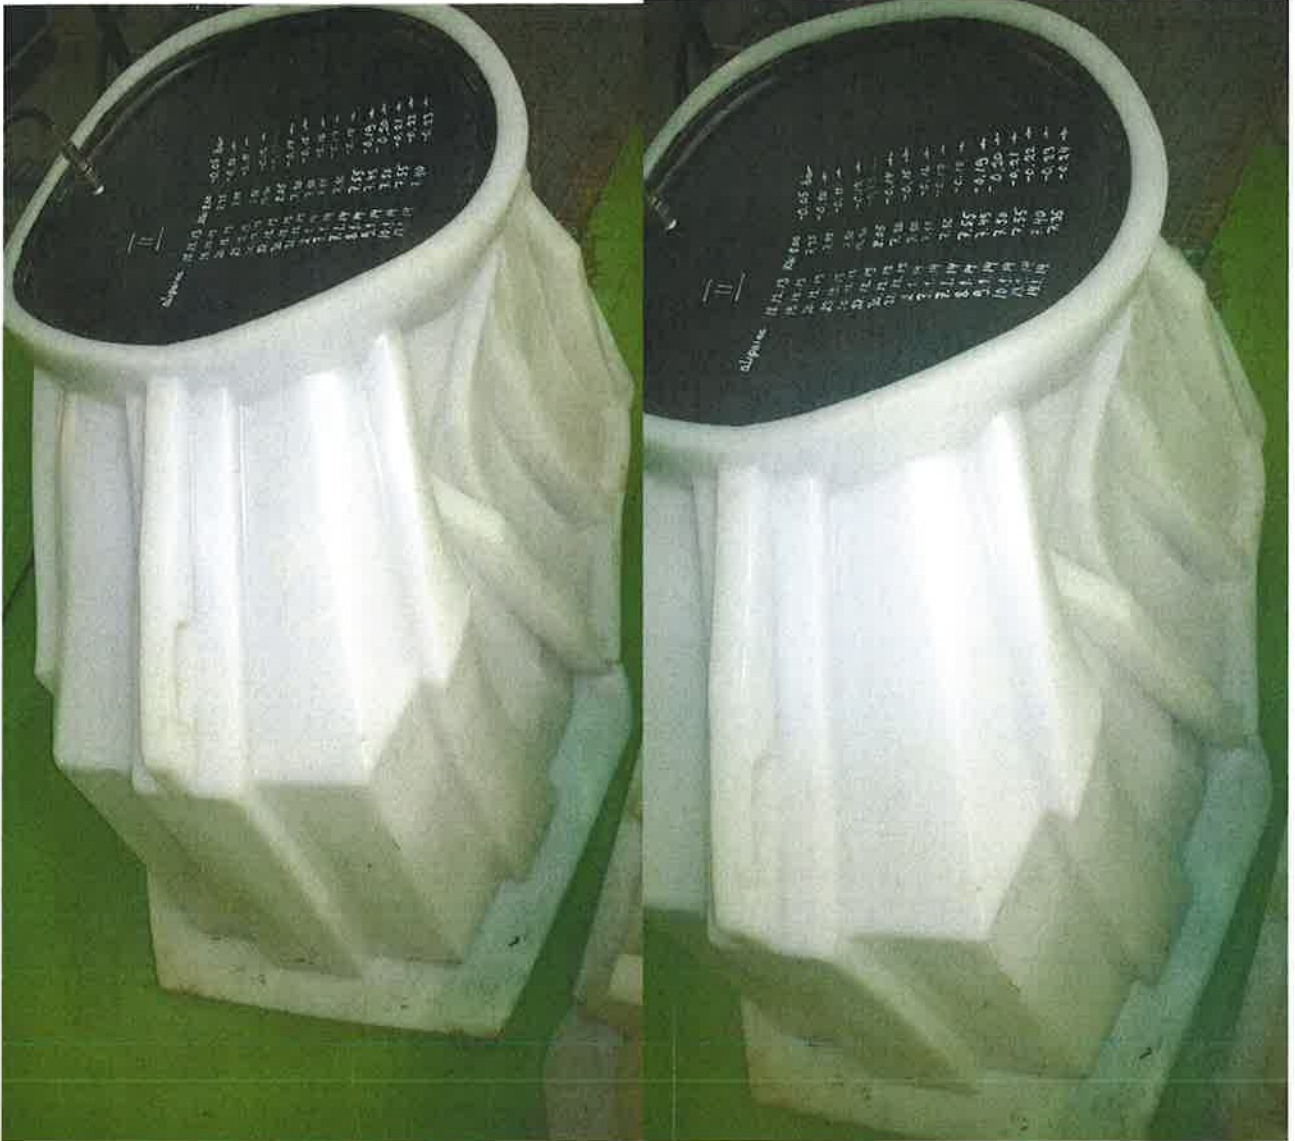
Picture 7 (KKS3 # II : 0,23 bar vacuum)

Picture 8 (KKS3 # II : 0,24 bar vacuum)

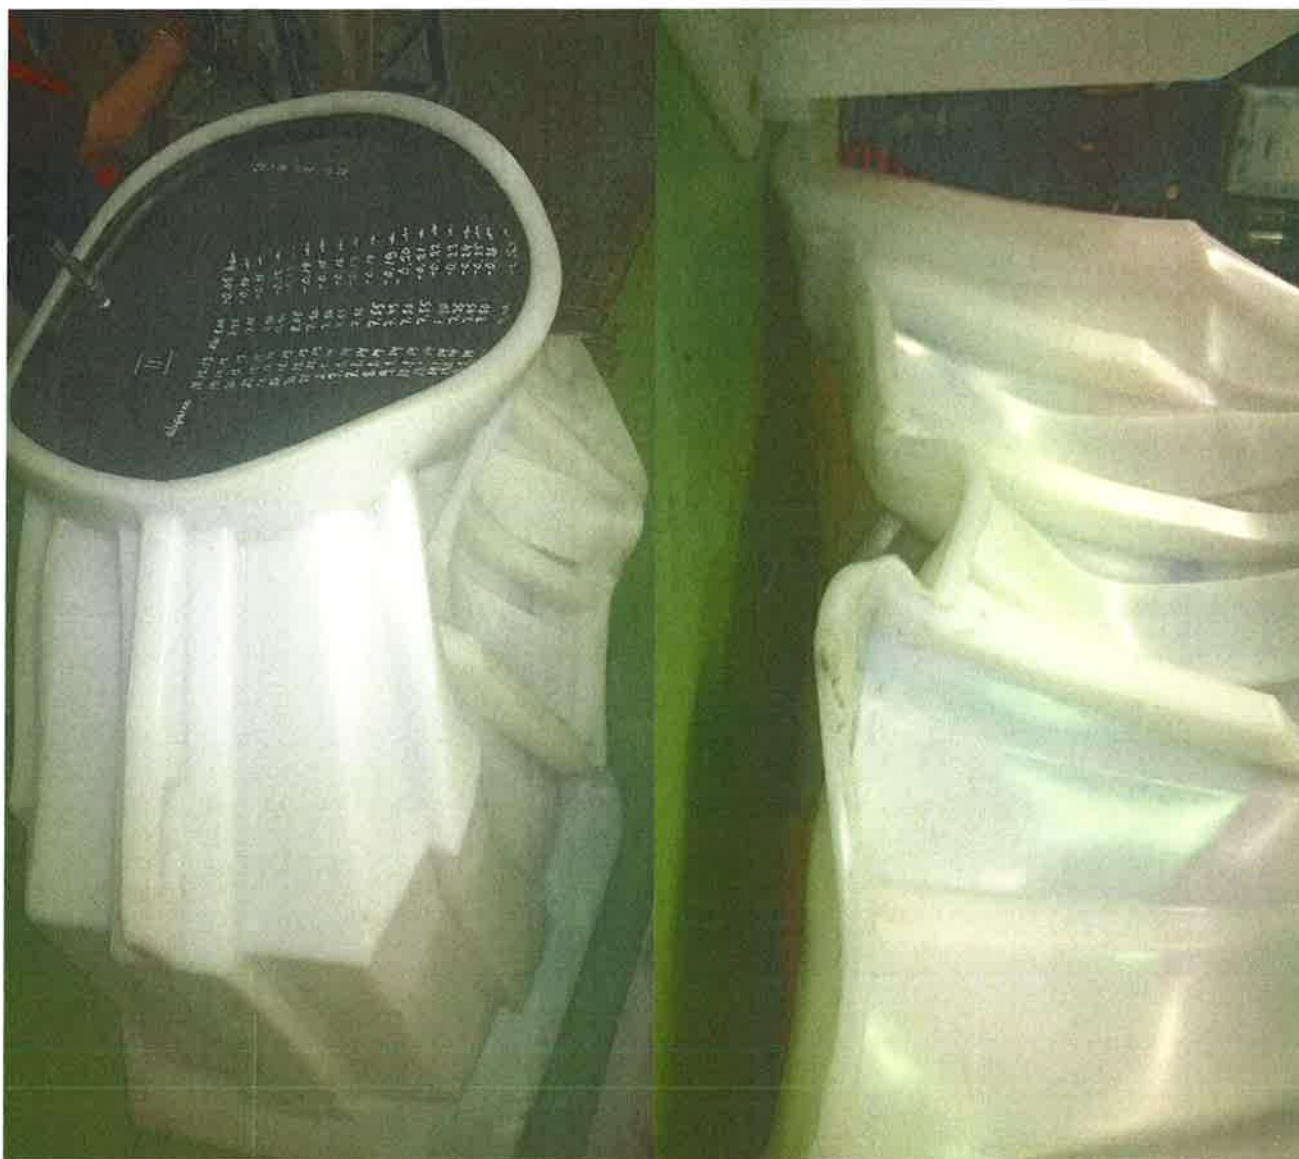
The KKS3 #2 chamber was tight until 0.26 bar vacuum and when increased to 0.27 the chamber started leaking.

Picture 9 (KKS3 # II : 0,26 bar vacuum)

Picture 10 (KKS3 # II : 0,26 bar vacuum)

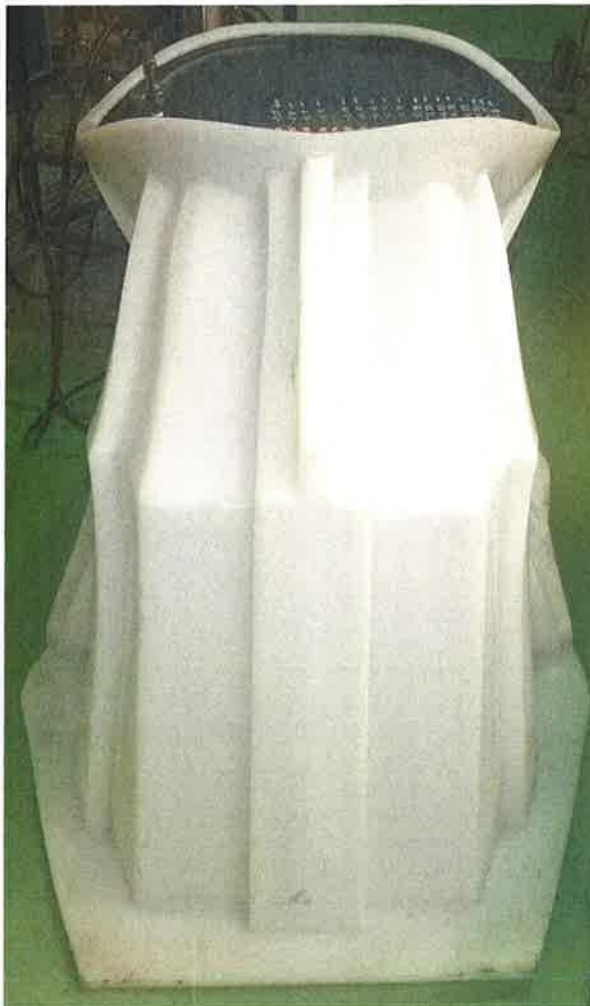
The material of KKS3 #2 was a little bit tougher than the material of KKS3 #1. The KKS3 #2 kept its shape rather well until 0.20 bar vacuum.

Picture 11 (KKS3 # II : 0,20 bar vacuum)
